iCYCLONE CHASE REPORT

storm	Hurricane PATRICIA		
location	Emiliano Zapata, Jalisco, Mexico		
date	23 October 2015		
chasers	Josh Morgerman, Erik Sereno	author	Josh Morgerman

Hurricane PATRICIA was a small, extremely powerful hurricane that made a bull's-eye, direct hit on Emiliano Zapata, devastating that town and nearby villages along the Jalisco coast of Mexico.

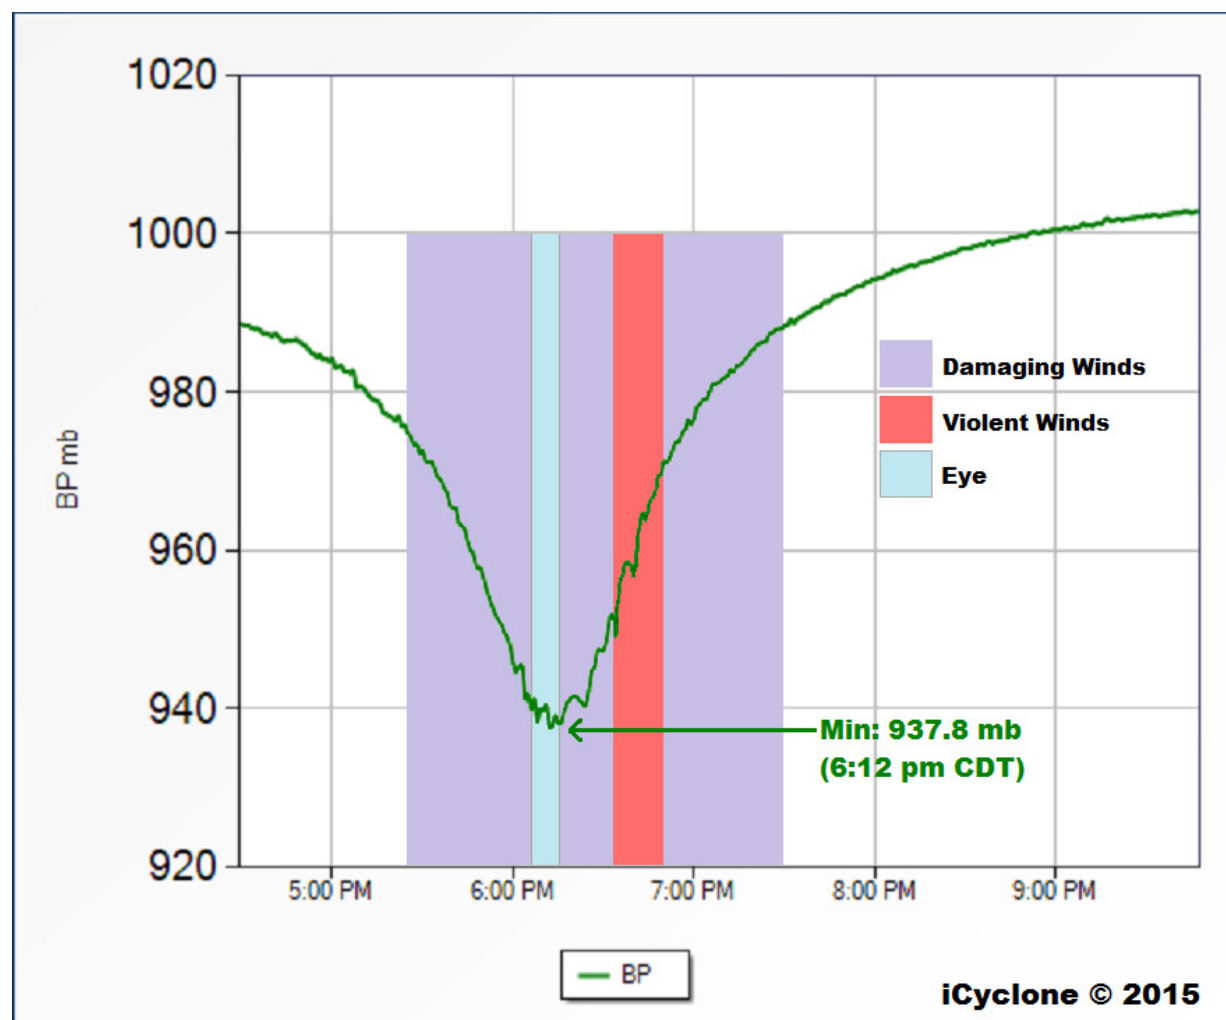
Storm Summary Infographic

The following infographic combines my surface observations and air-pressure data into a single, consolidated summary of Hurricane PATRICIA's passage over our chase location in Emiliano Zapata.

These observations and data are described in more detail later in this report:

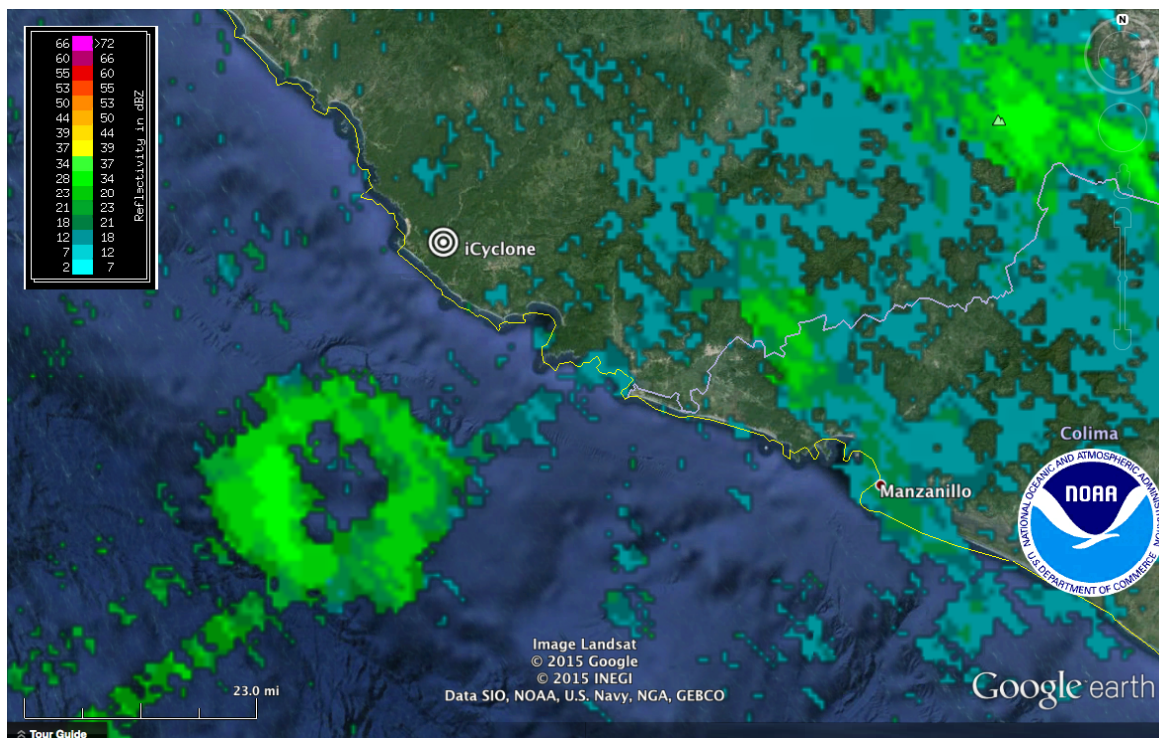
The last reconnaissance radar image (from 4:51 pm CDT (2151Z)) suggests the hurricane's core remained very small as it wobbled toward the coast. PATRICIA was a tiny and difficult-to-chase target:

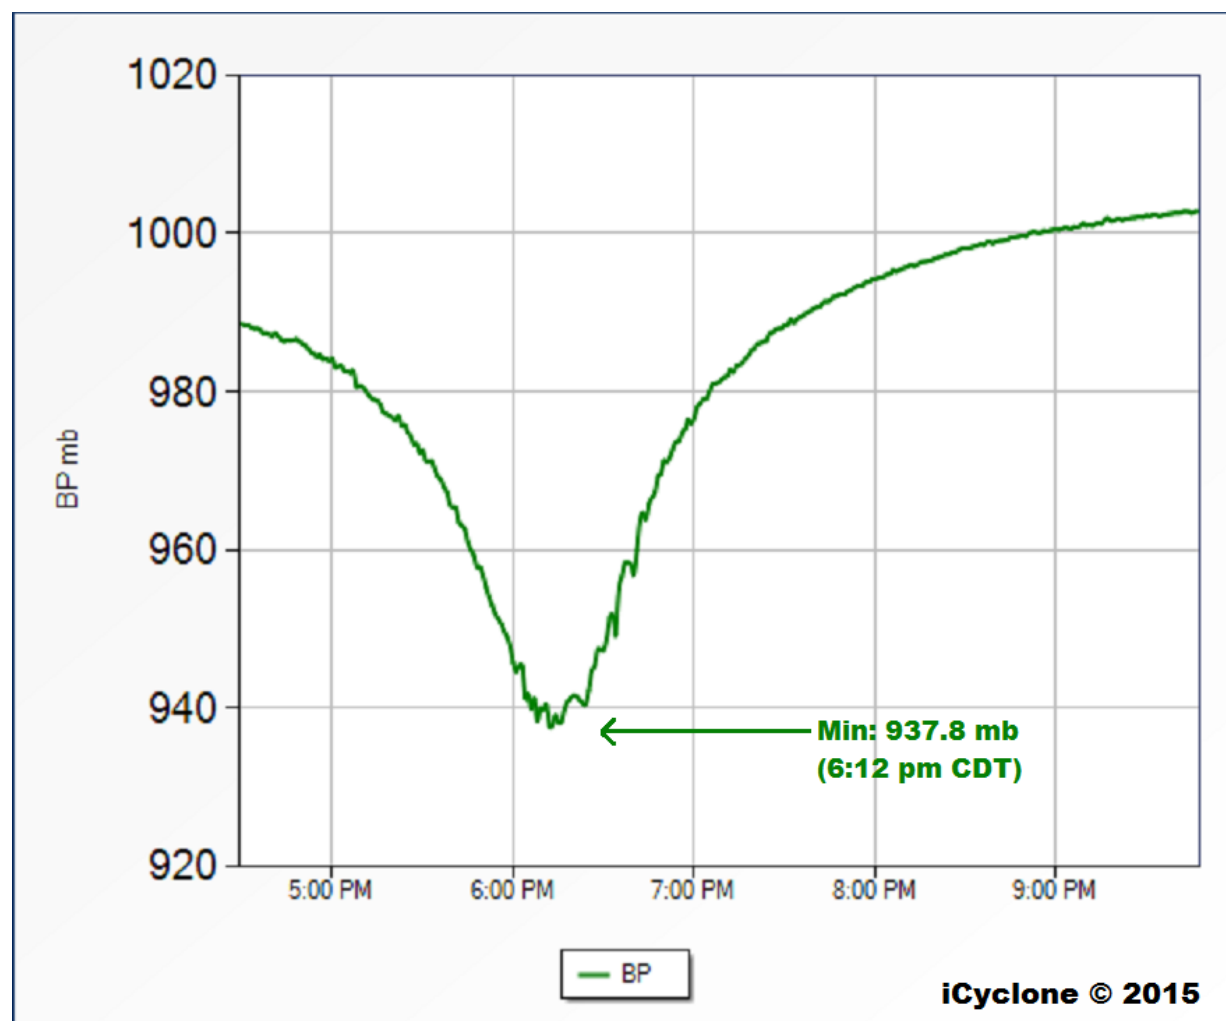
Barogram—Device 1

The pressure traces for **Devices 1 and 2** are below: **Barogram—Device 1** and **Barogram—Device 2**. **Barogram—Device 1 (CLOSE)** is a zoomed-in look at the **Device 1** data collected during the passage of the cyclone’s core.

Devices 1 and 2 matched fairly well, showing minimum readings of ~938 mb a little after 6 pm, during the passage of the eye:

- **Device 1: 937.8 mb at 6:12 & 6:13 pm.**
- **Device 2: 938.2 mb at 6:09 pm.**

Applying this methodology and a forward speed of 12 kt, **Device 2** showed a whopping peak gradient of **11.4 mb/n mi** in PATRICIA's violent SE eyewall, as the center moved away from us. Using the faster forward speed of 13 kt reduces this value to a still-extreme **10.6 mb/n mi**. **Device 1's** peak gradient in the back eyewall was lower but still extreme: **8.9 mb/n mi** for 12 kt and **8.2 mb/n mi** for 13 kt.

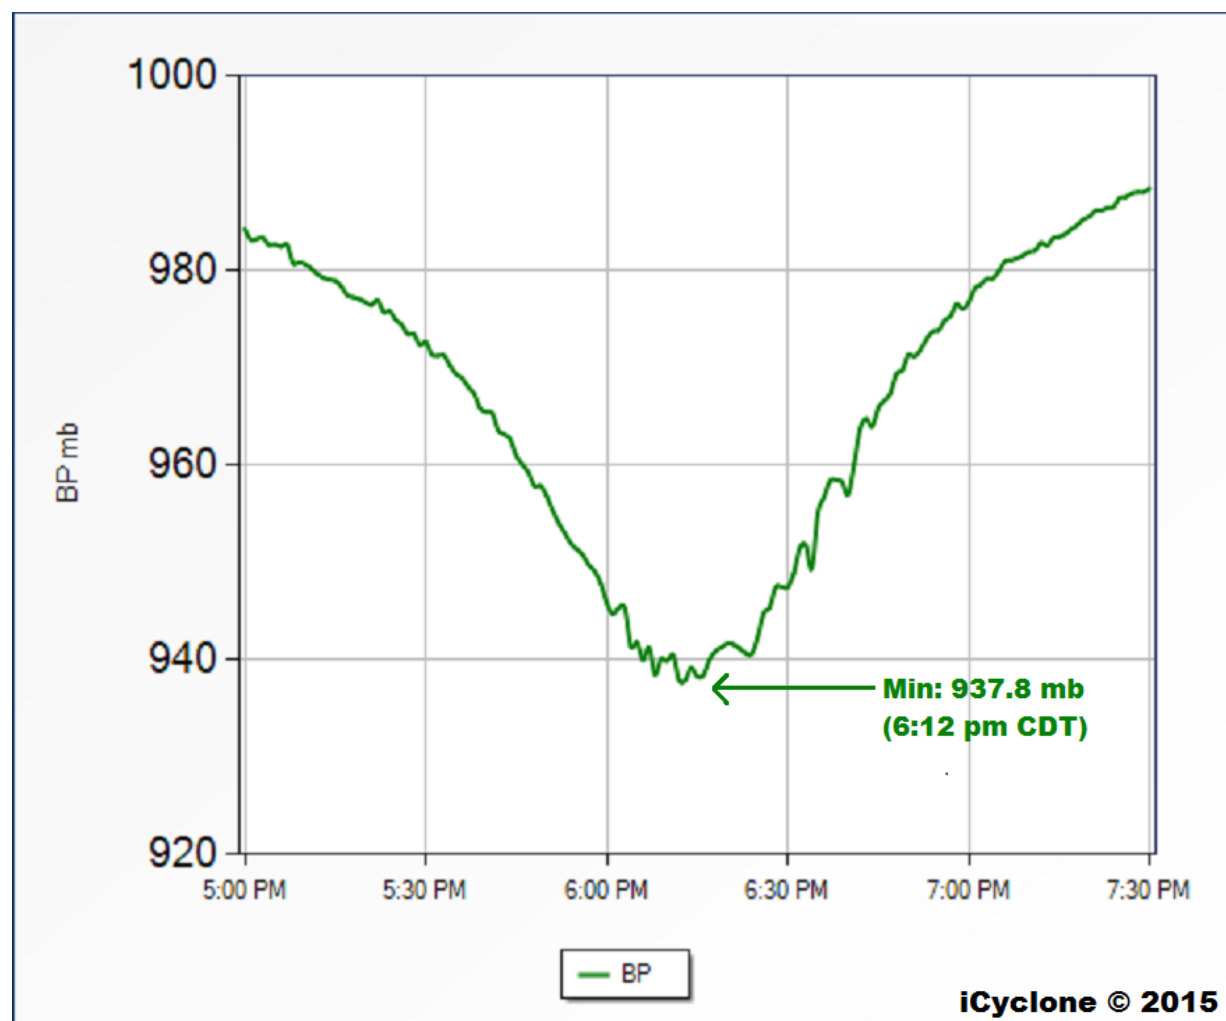
Barogram—Device 1 (CLOSE)

DEVICE 1 – CLOSE VIEW

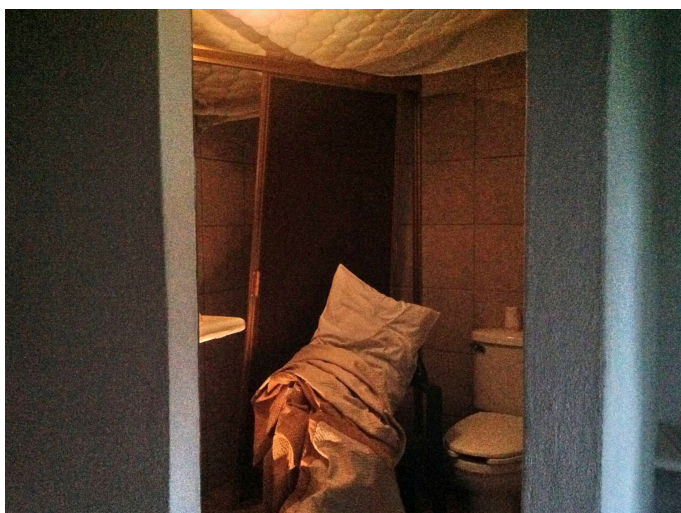
A large part of Hotel El Refugio lost its roof during the especially violent winds in the back (SE) eyewall. Rooms facing the S and W were especially exposed to the maximum winds and had the most damage. Several rooms were torn open, presenting great danger to the occupants. A family in one such room fled to ours and sought refuge with us at the height of the storm. Eight of us—six adults and two children—squeezed into this tiny bathroom (below) to ride out the most violent winds. Worried the roof would blow off our room, too, we wedged a mattress in the ceiling for added protection. Fortunately there were no major injuries in the hotel.

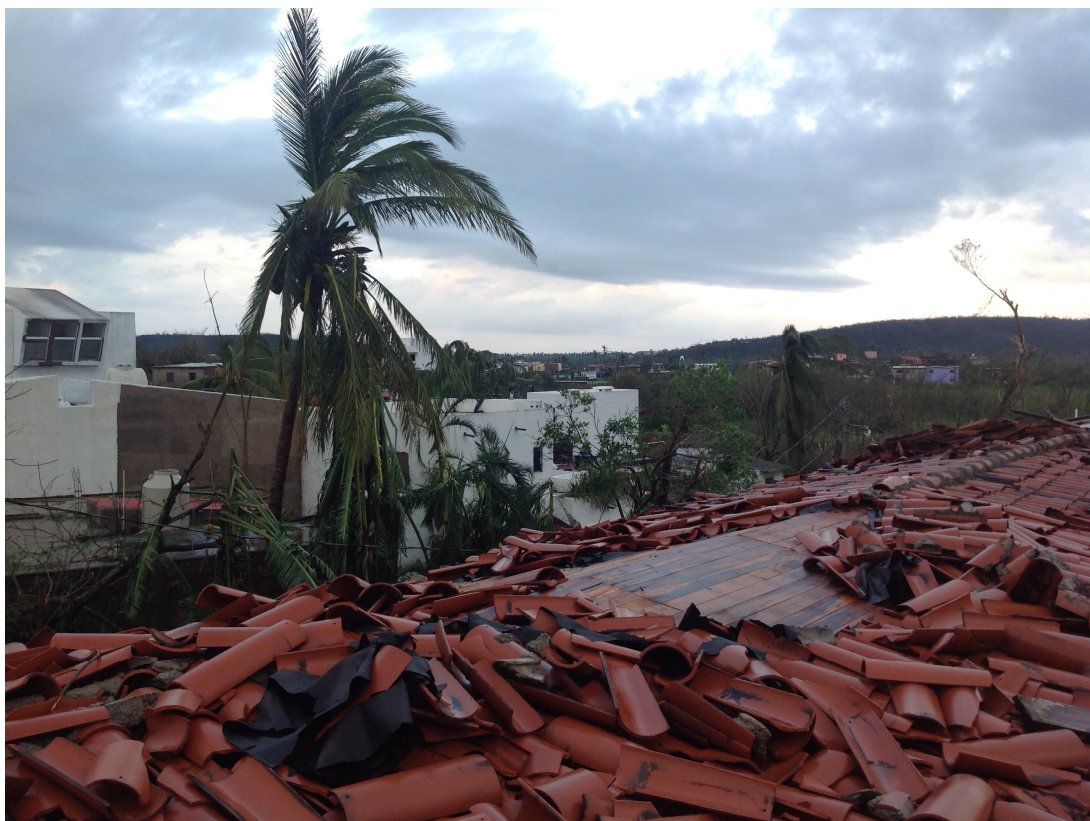
Damaged roof of Hotel El Refugio.

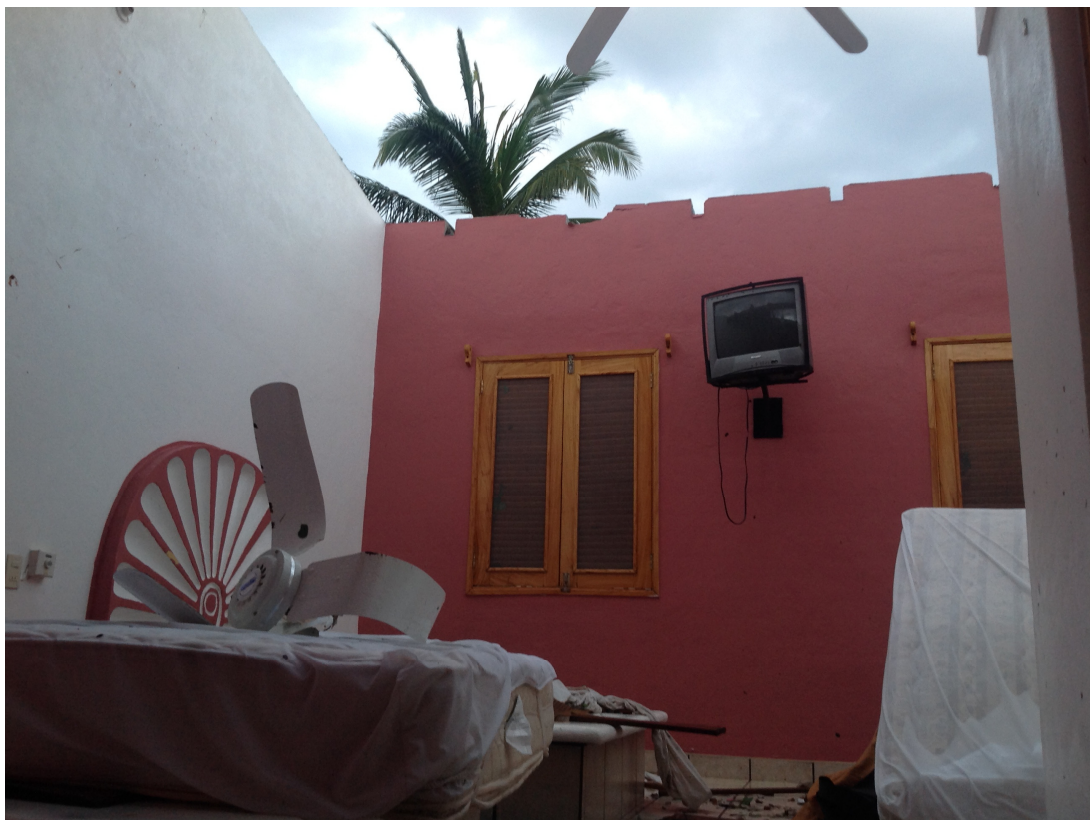
Roof damage from inside Hotel El Refugio. The family in this room saw the entire roof lift into the air. They joined the author and his chase partner across the hall, where we all took cover.

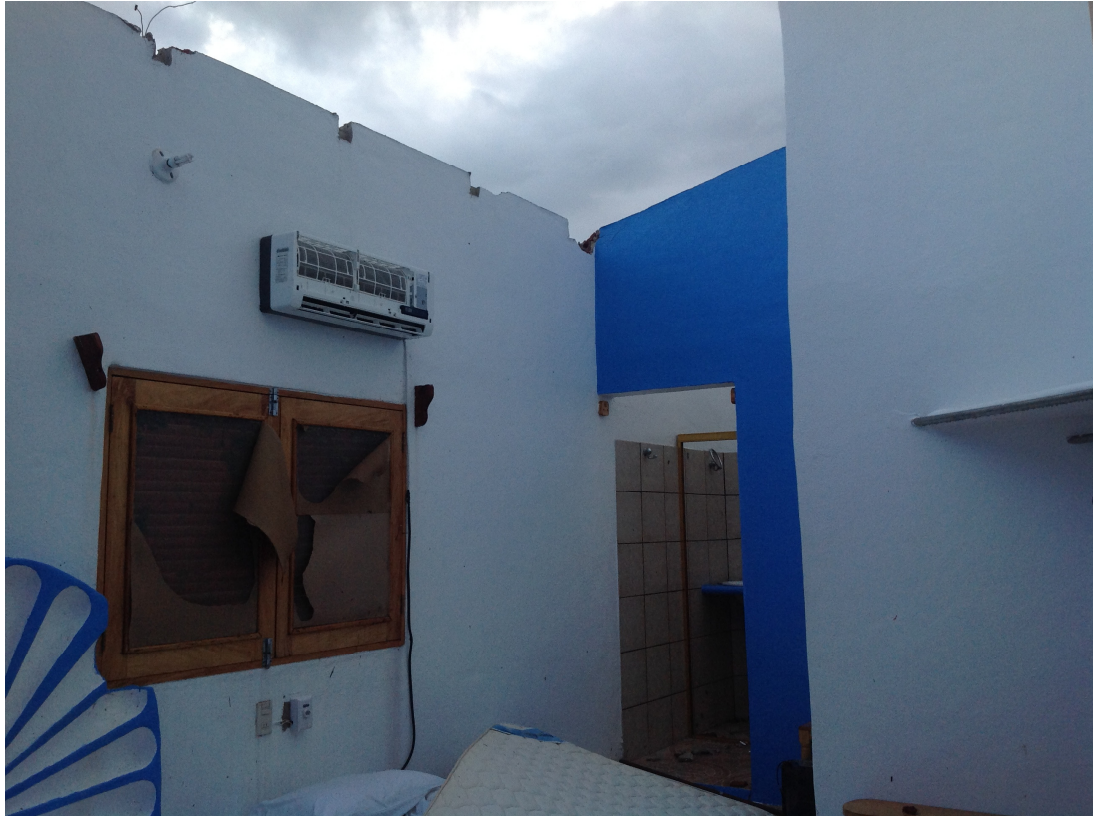
Roof damage from inside Hotel El Refugio.

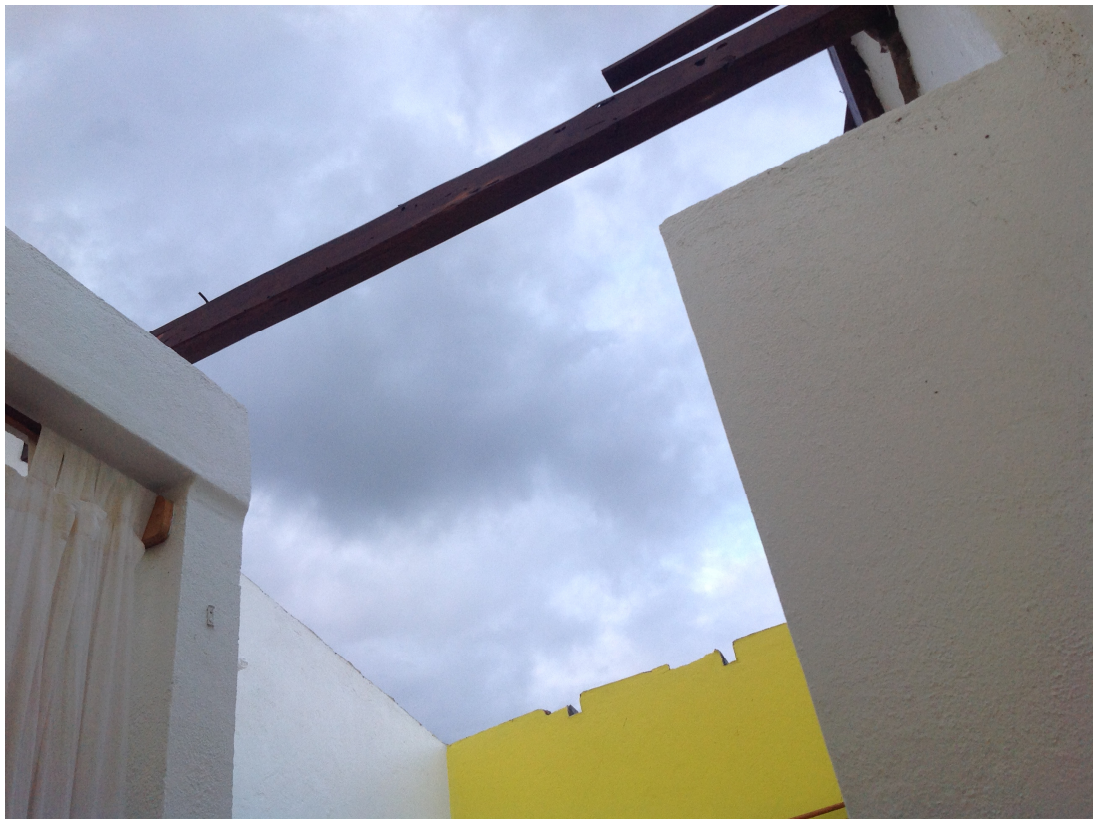
Roof damage from inside Hotel El Refugio.

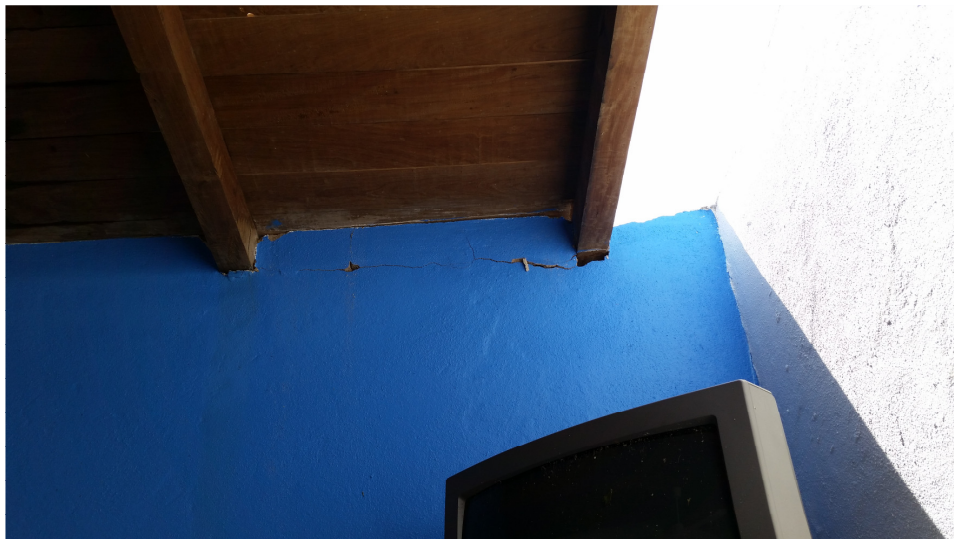
The roof partially stayed on here—but notice the lifting stress cracked the wall.

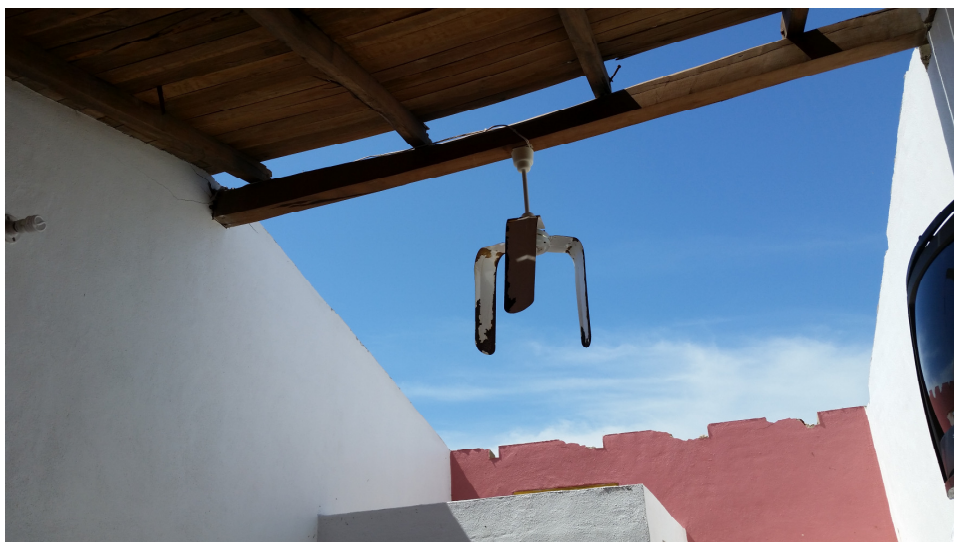
Roof damage. Notice how the roof tore away parts of the wall as it lifted off.

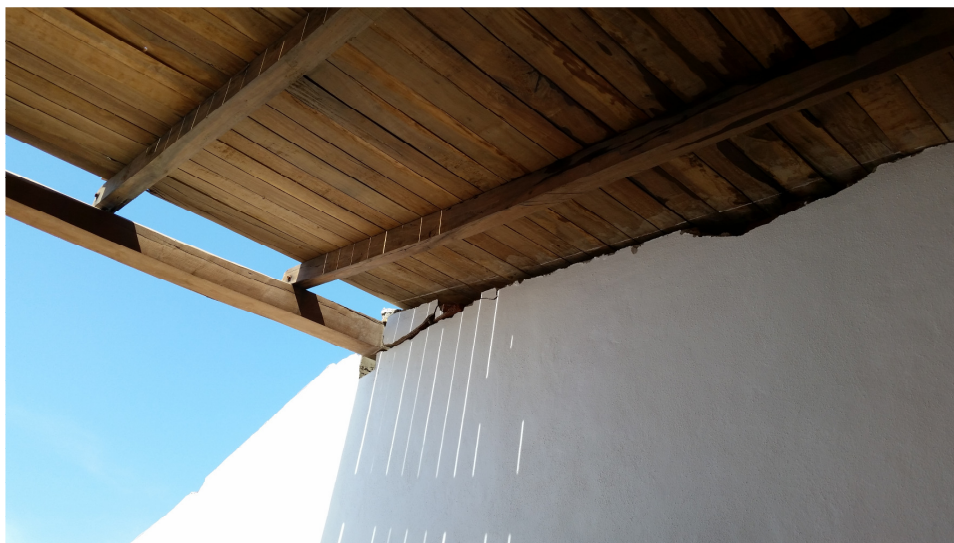
The roof partially stayed on in this room—but again, notice the cracked wall.

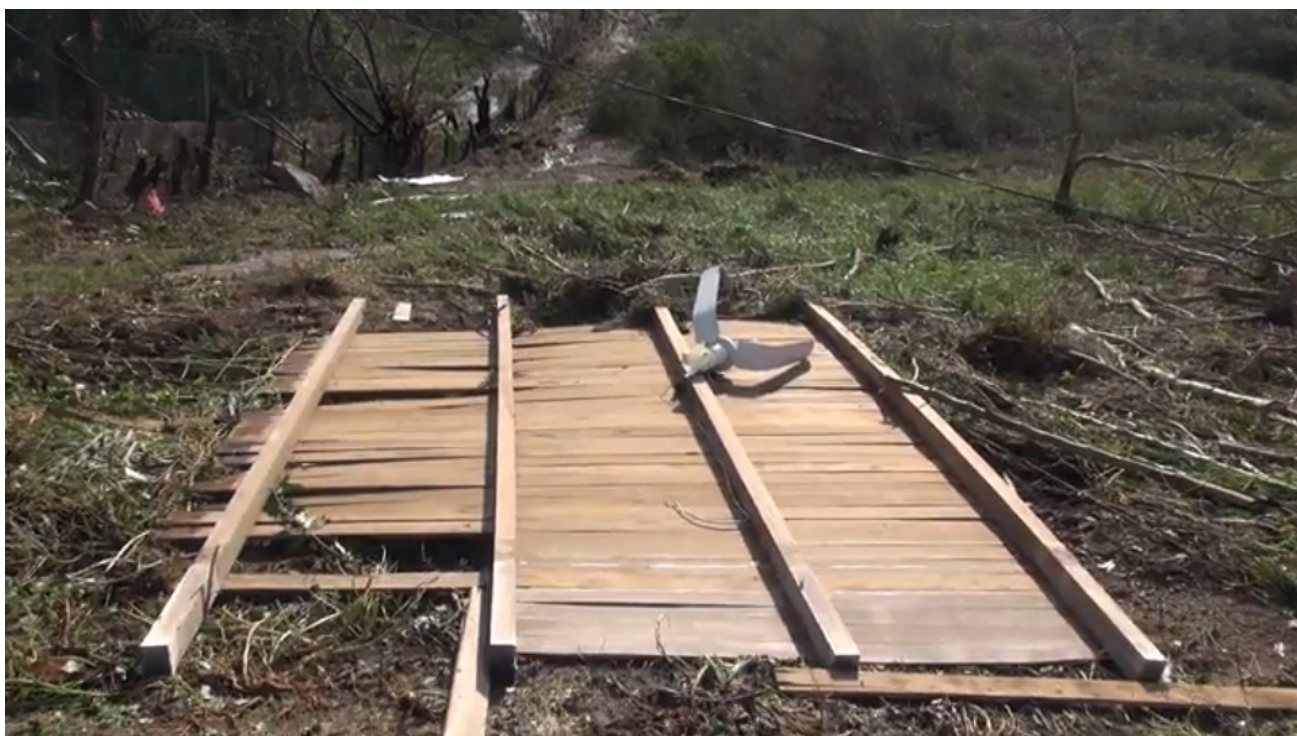
We found a large portion of Hotel El Refugio's roof across the highway. The resting point suggests winds during the violent SE eyewall were W or WSW.

* This wind direction at 6:33 and 6:35 pm was not directly observed, but was inferred afterward from the location of the hotel's roof across the street.

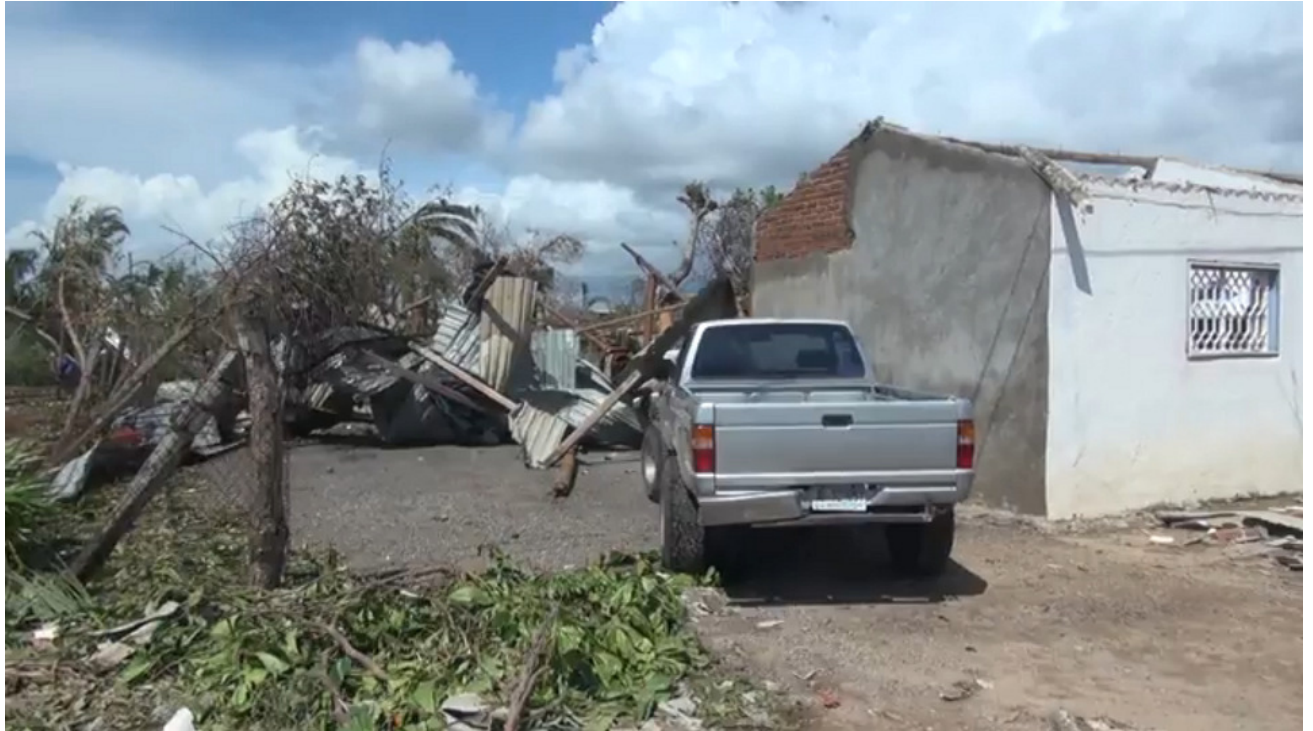
Heavy damage to a home in Emiliano Zapata.

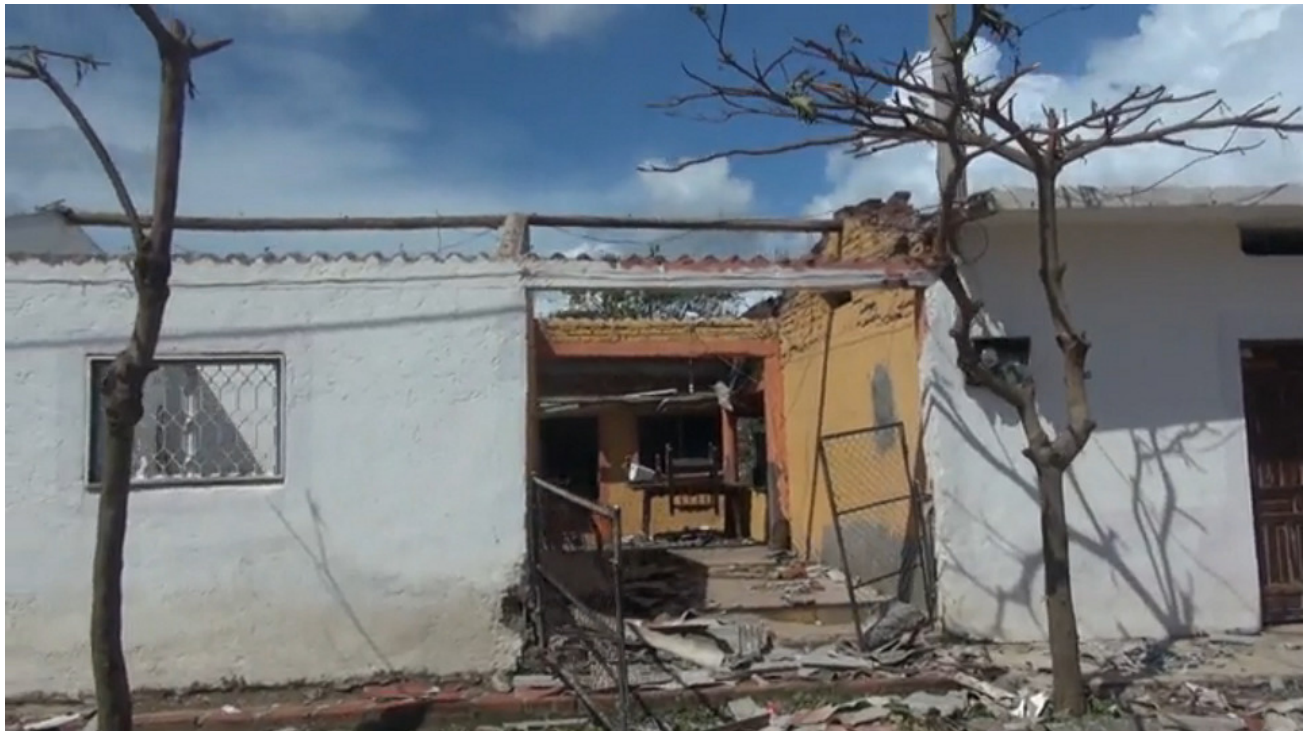
Heavy damage to a home and completely stripped, defoliated trees in Emiliano Zapata.

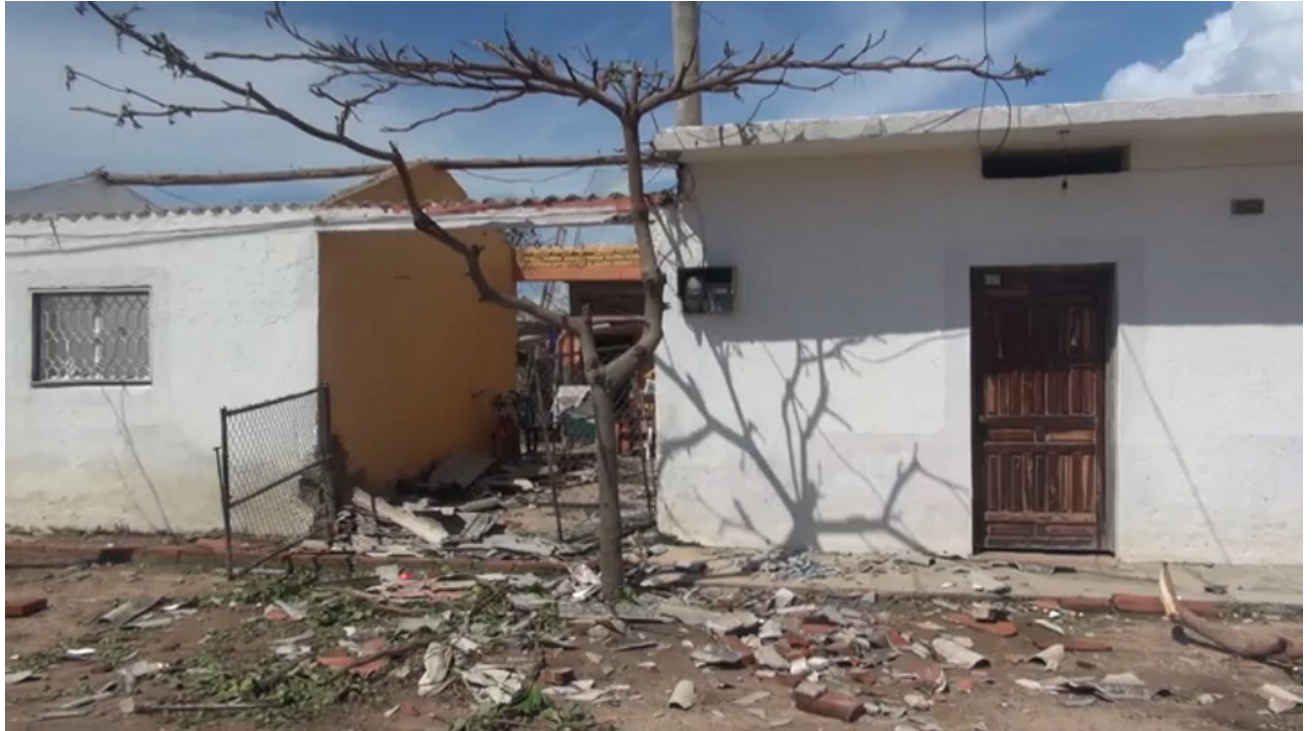
Heavy damage to a home and completely stripped, defoliated trees in Emiliano Zapata.

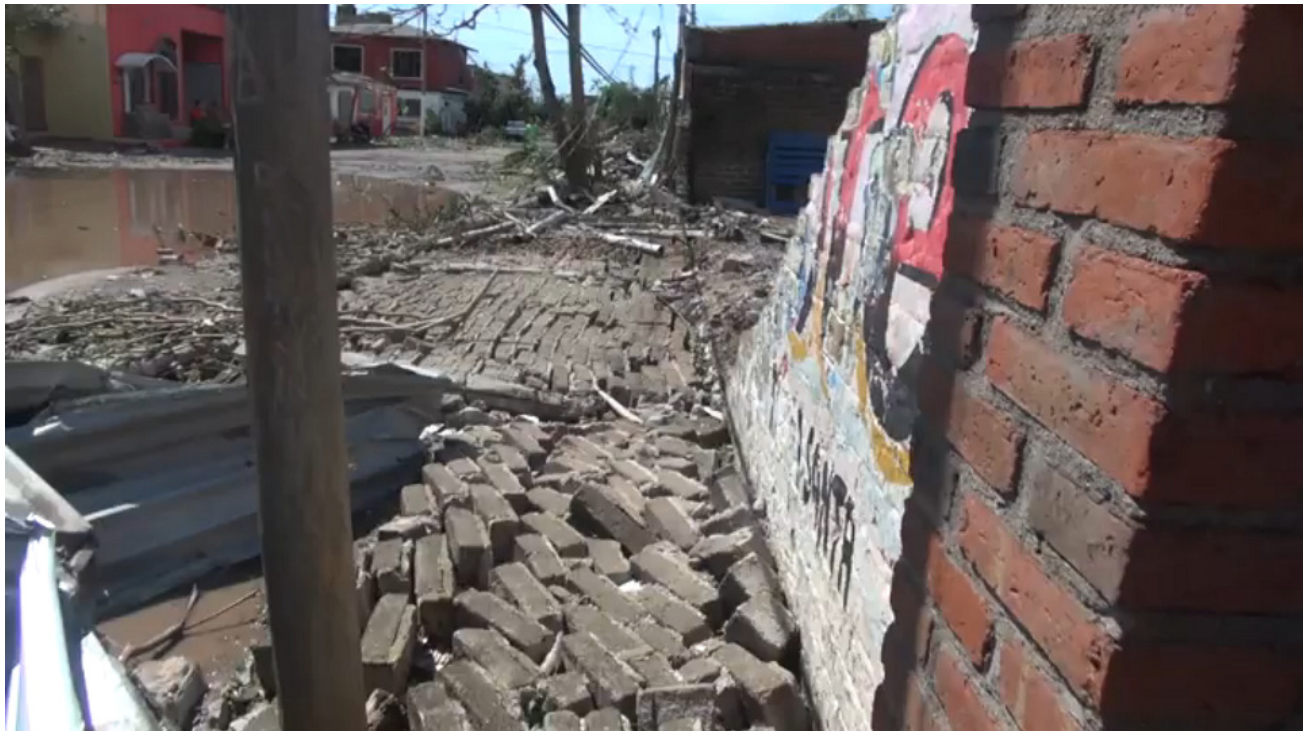
Collapsed brick wall in Emiliano Zapata.

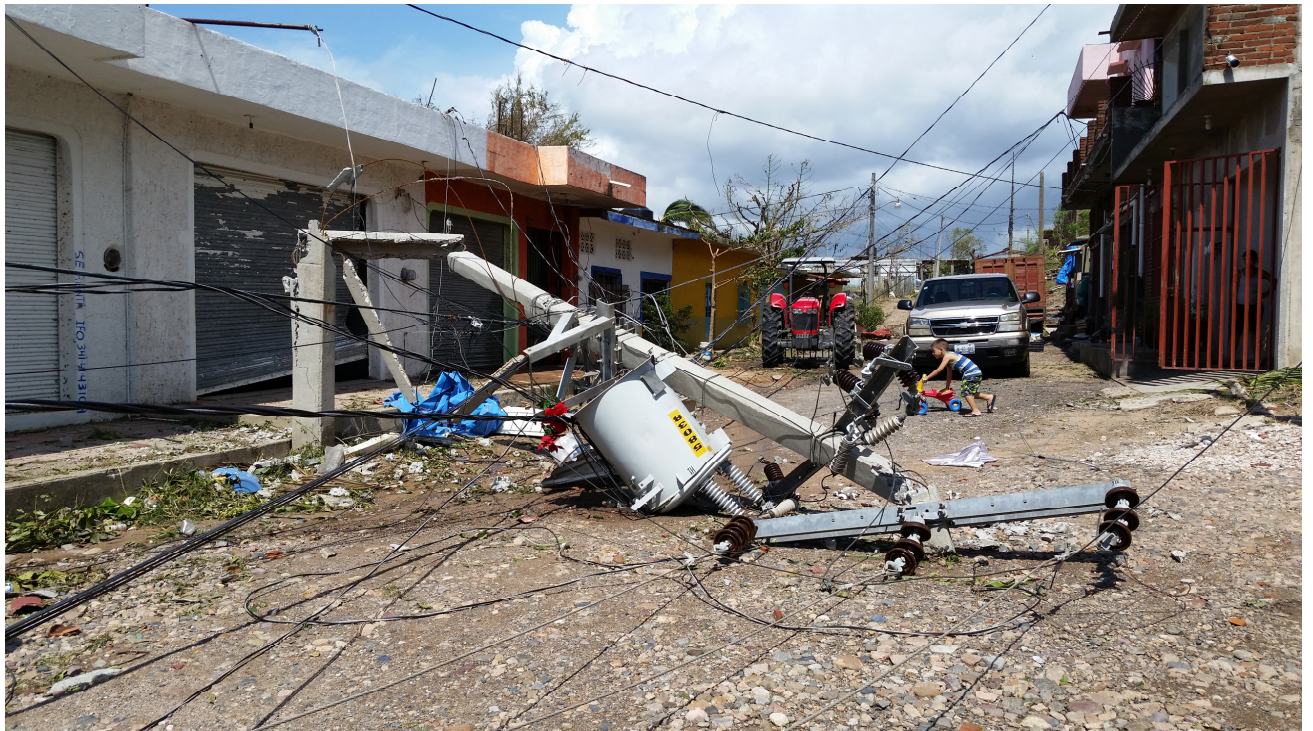
Smashed concrete power pole in Emiliano Zapata.

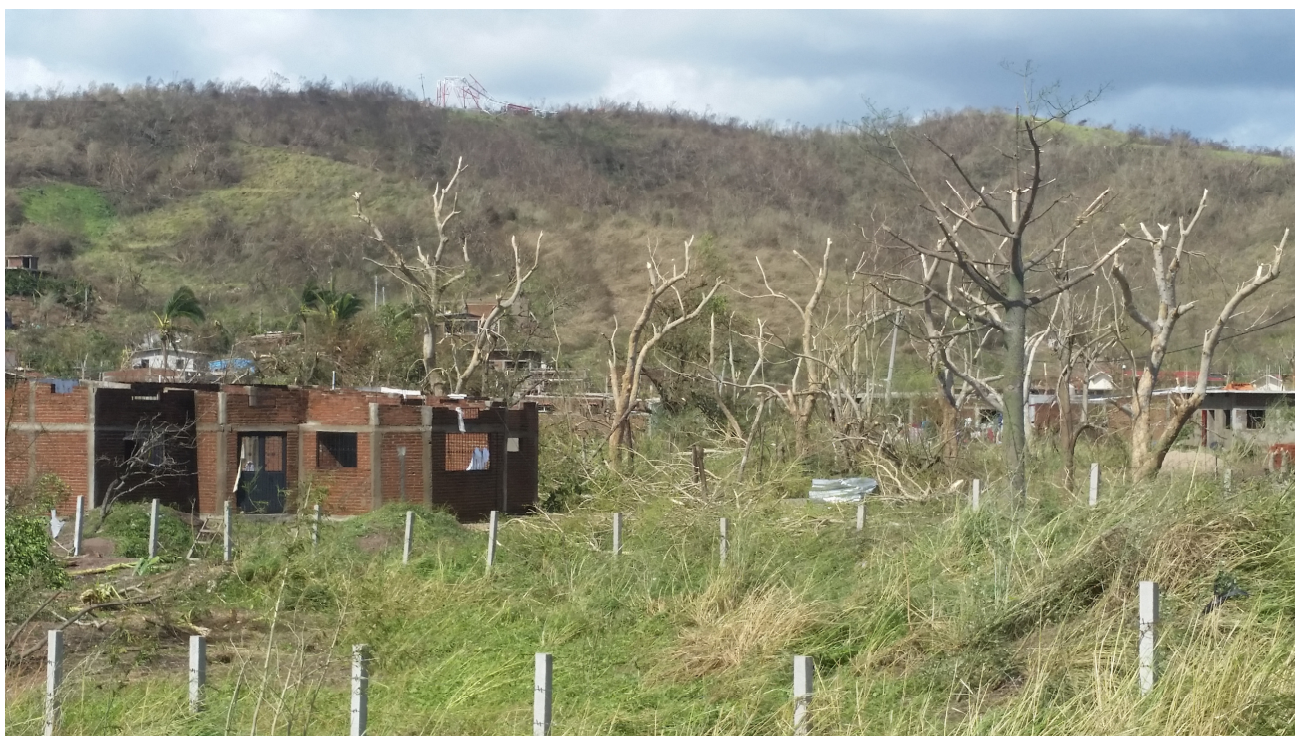
Completely stripped, defoliated trees; gutted house; and dead hillsides near Emiliano Zapata.

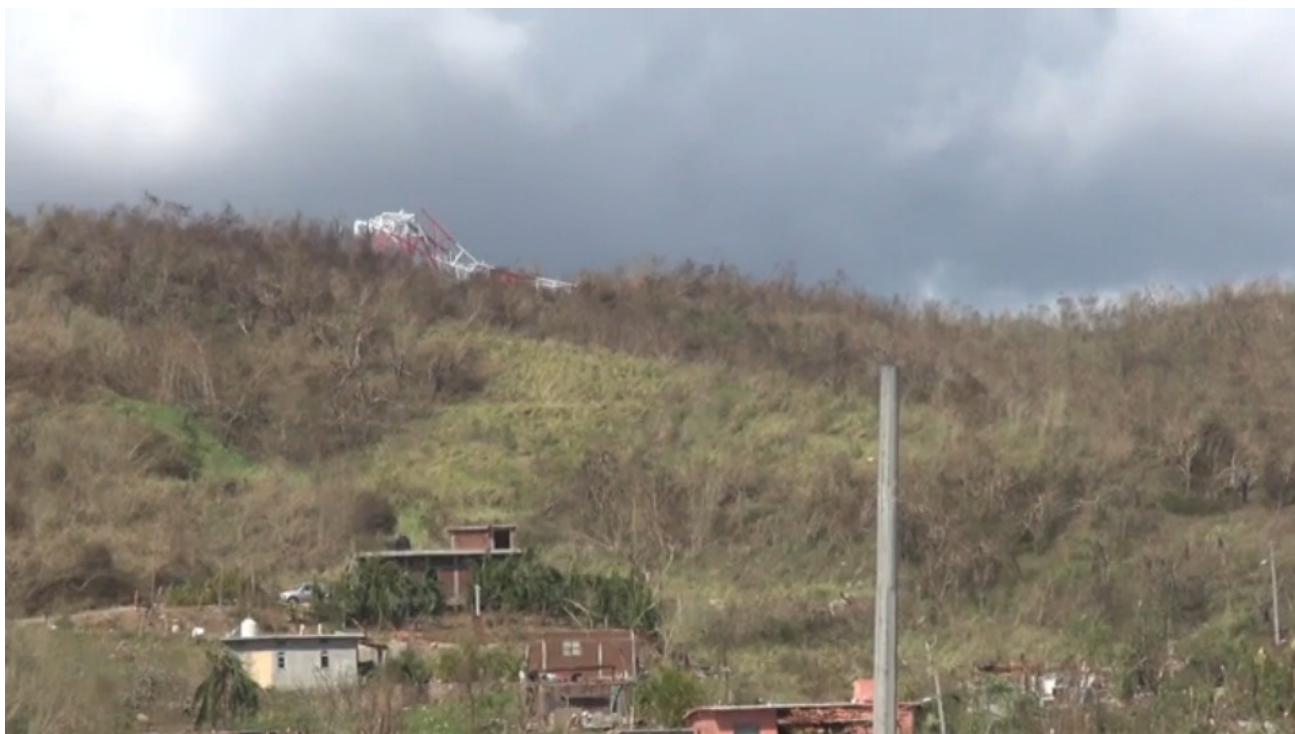
Crumpled communications tower atop stripped, dead hillsides near Emiliano Zapata. Notice the near 100% blowdown of the trees.

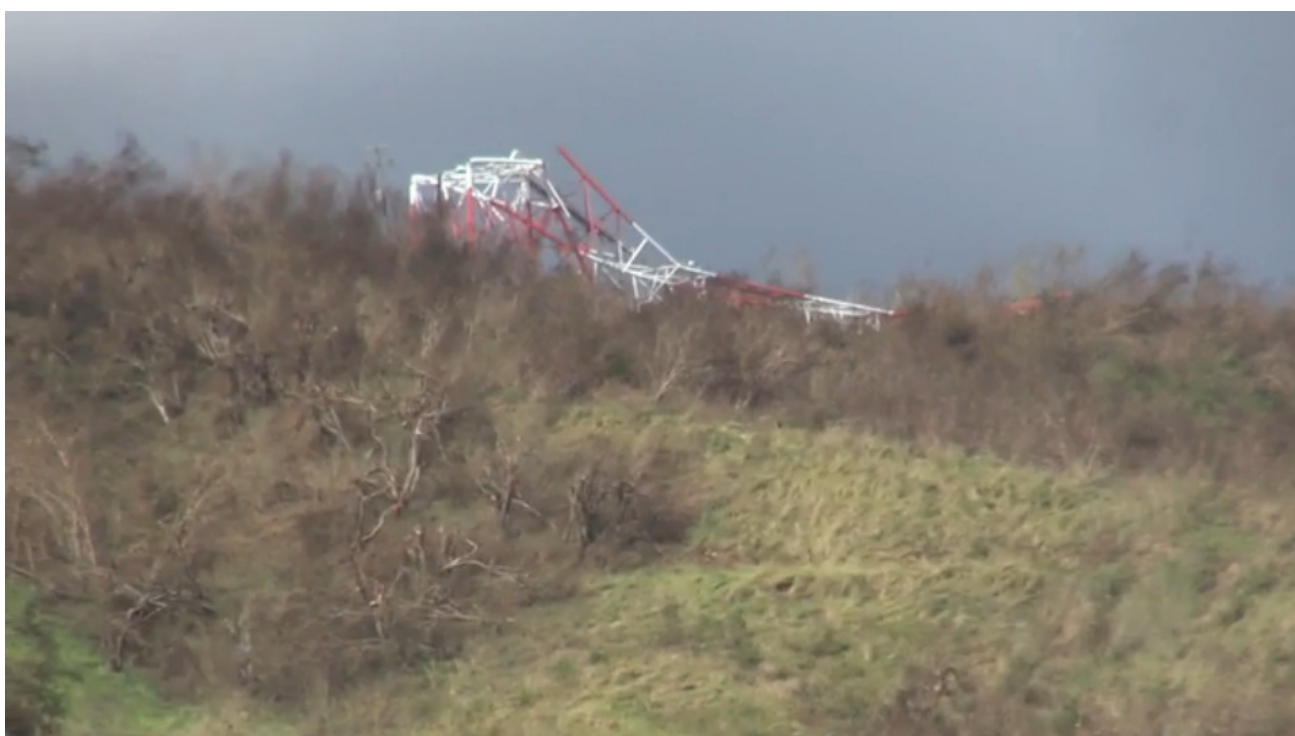
Close shot of the crumpled communications tower near Emiliano Zapata.

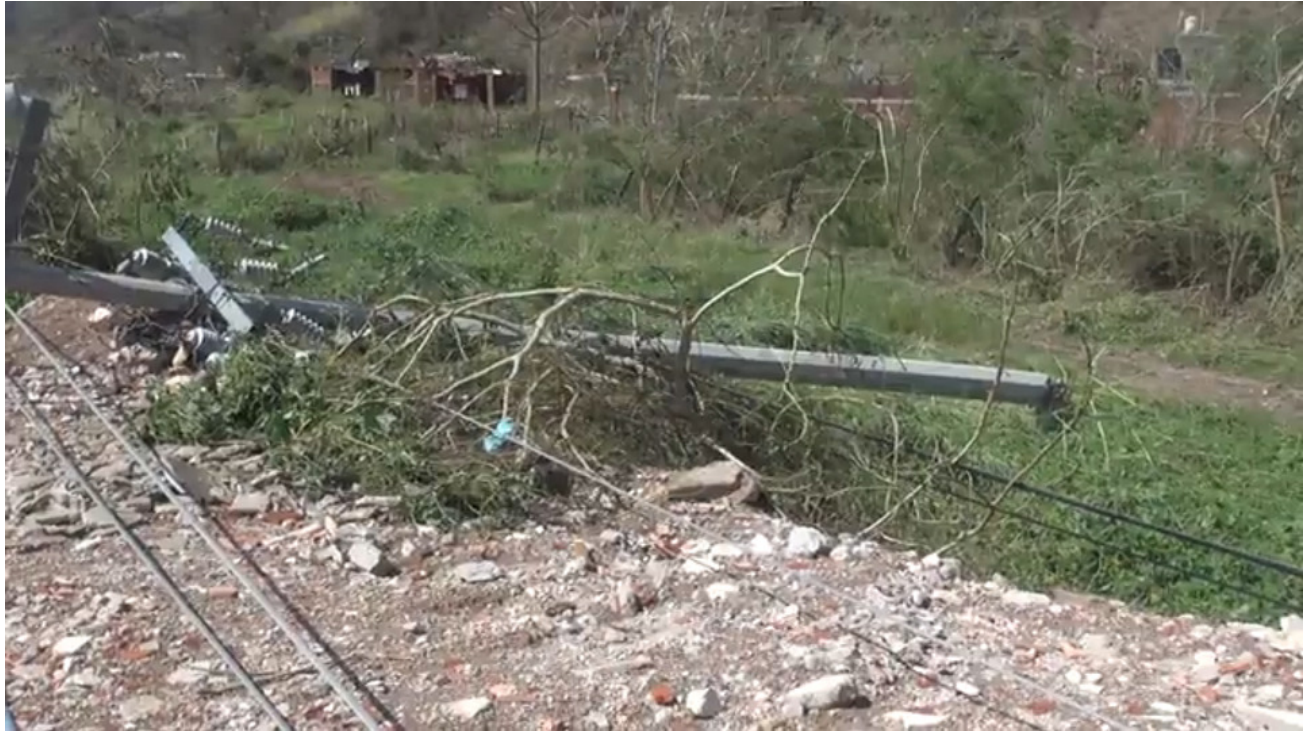
Smashed power pole near Emiliano Zapata.

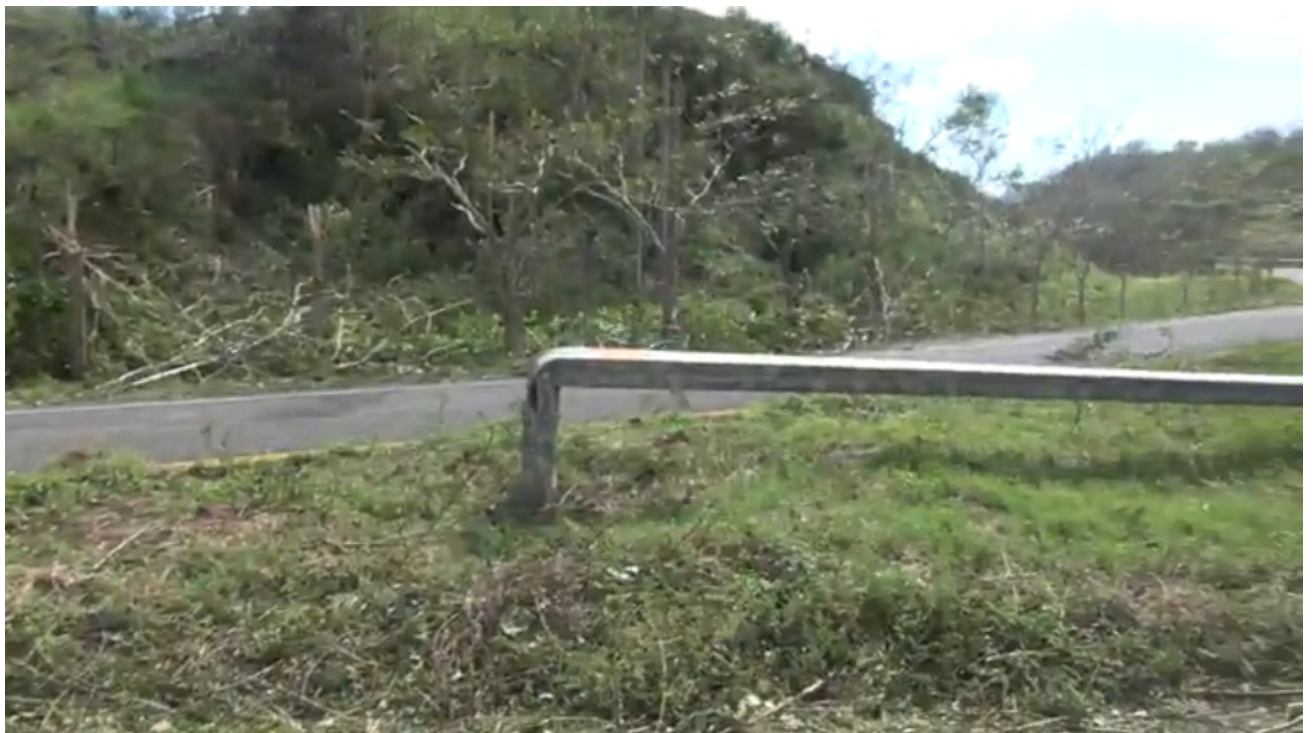
Bent signpost along Highway 200 between Emiliano Zapata and Agua Caliente.
