ICYCLONE CHASE REPORT

storm	Hurricane JOVA		
location	Emiliano Zapata, Jalisco, Mexico		
date	11-12 October 2011		
chasers	Josh Morgerman, Jim Edds	author	Josh Morgerman

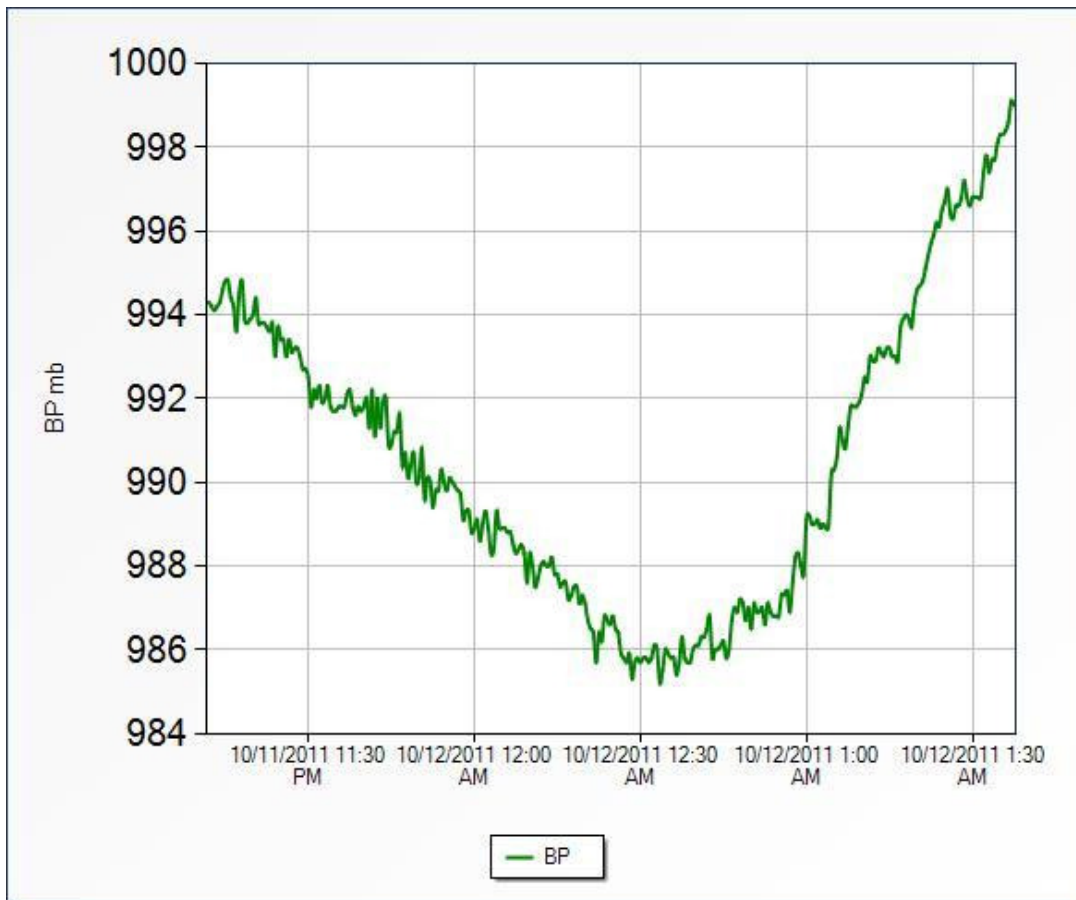
Figure 3: Barogram

- **Lowest pressure.** I measured a low pressure of **985.2 mb at 12:33 am CDT**, as the center passed to our W. (See the **Barogram** for a complete record of the pressure's fall and rise as Jova's center passed nearby. The sampling rate was 30 seconds.)
 - **Note:** The barometer, a **Kestrel 4500**, was calibrated for sea-level readings using an altitude of 73 ft, which is what the car GPS system indicated. The exact accuracy of that altitude is unknown, and it could be 10-20 ft higher or lower.
- **Maximum winds.** Winds became destructive starting around 11:30 pm CDT and **peaked between about 12:45 am to 1:00 am, as the SE eyewall apparently crossed the area.** The peak winds came in violent bursts, generally from the S, lasting 15 seconds to over 1 minute each. These bursts were accompanied by extremely heavy rainfall causing near whiteout conditions.

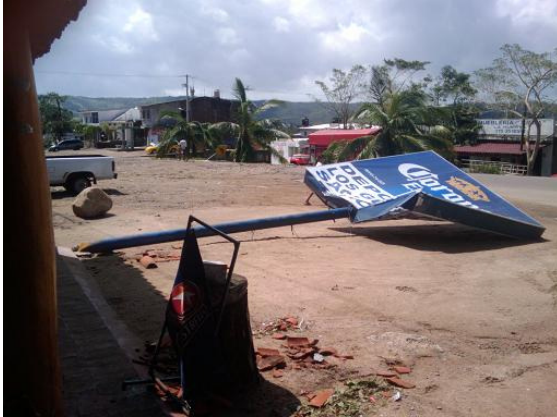
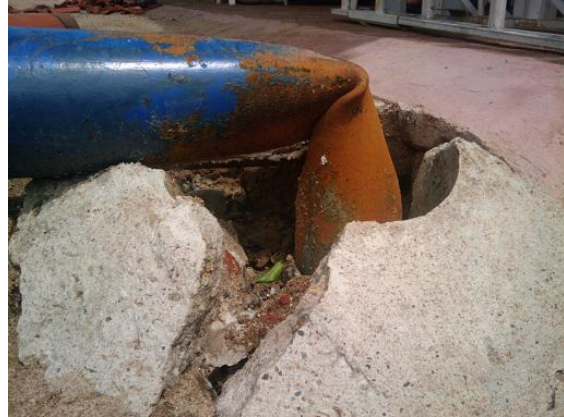
The mangled sign that crashed down onto the roof of our carport during the cyclone (photographed the next day).

- **12:33 am**
 - **Precip/sky:** Moderate rain.
 - **Wind:** Gusty, damaging—generally S; large sign bends and falls on the roof of the carport.
 - **Pressure:** **985.2 mb (lowest)**

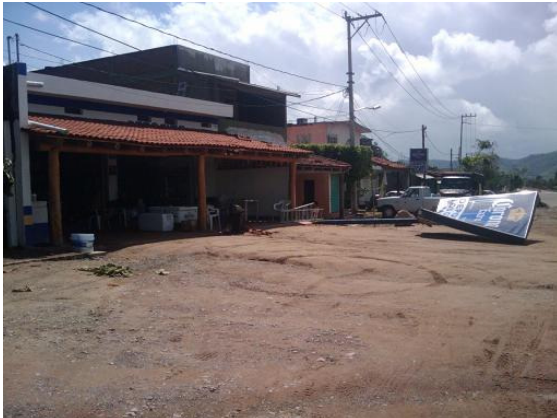
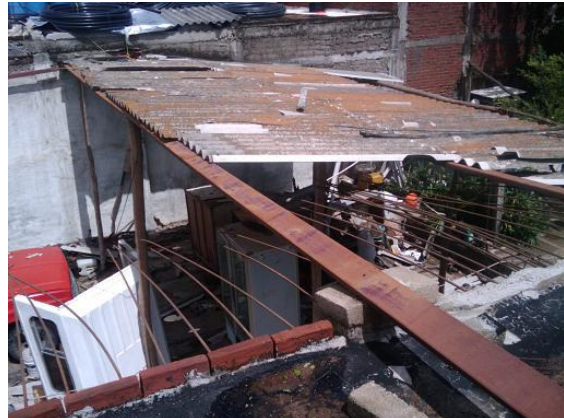
On the left is the carport/market where we rode out the cyclone. To the right is the unroofed building next door.

I returned to our chase location the day after the storm. Given the violence of the winds, the town looked surprisingly intact. This is probably because a lot of the houses and buildings are made of solid concrete or brick (including the roofs), so these types of structures did fine. Tile roofs were extensively damaged, and thatched or tin ones were in some instances completely destroyed.

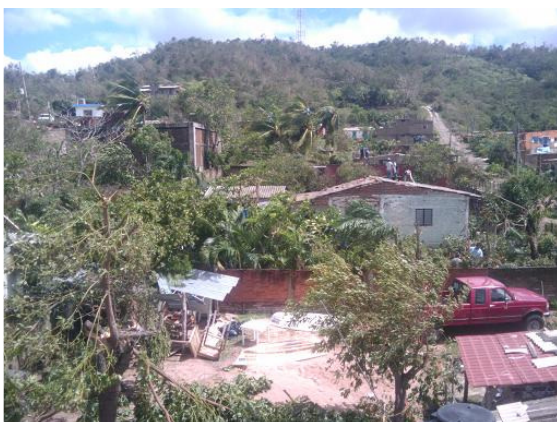
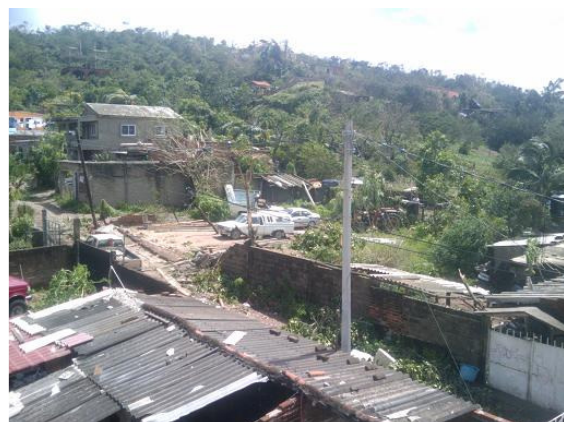
Trees that were not blown down had lost branches and were partially defoliated and “burnt” looking.

Various shots of Emiliano Zapata after the hurricane—showing the town damaged but mostly intact.

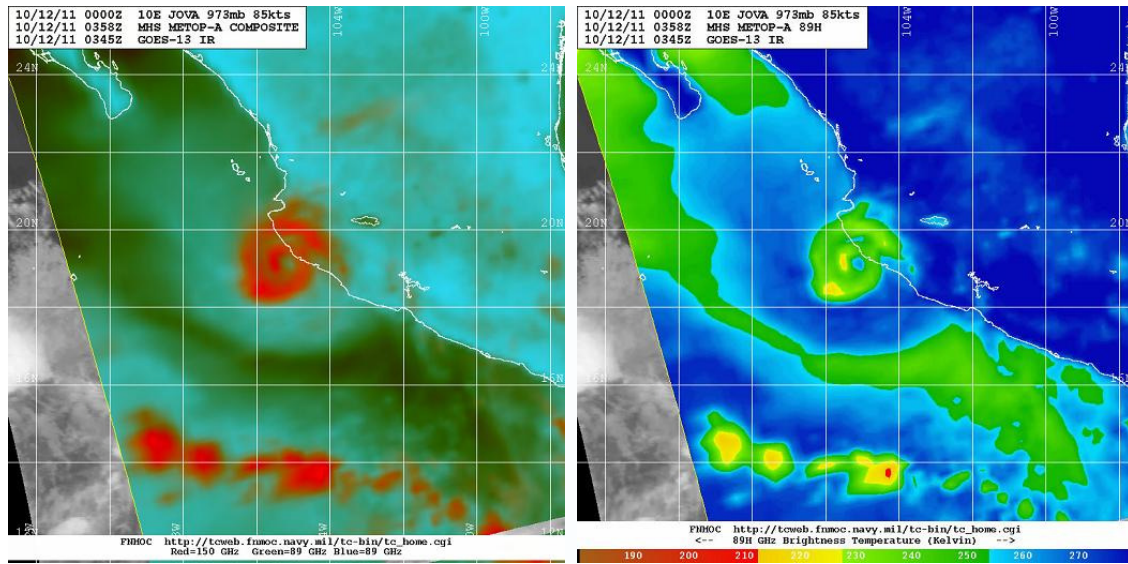
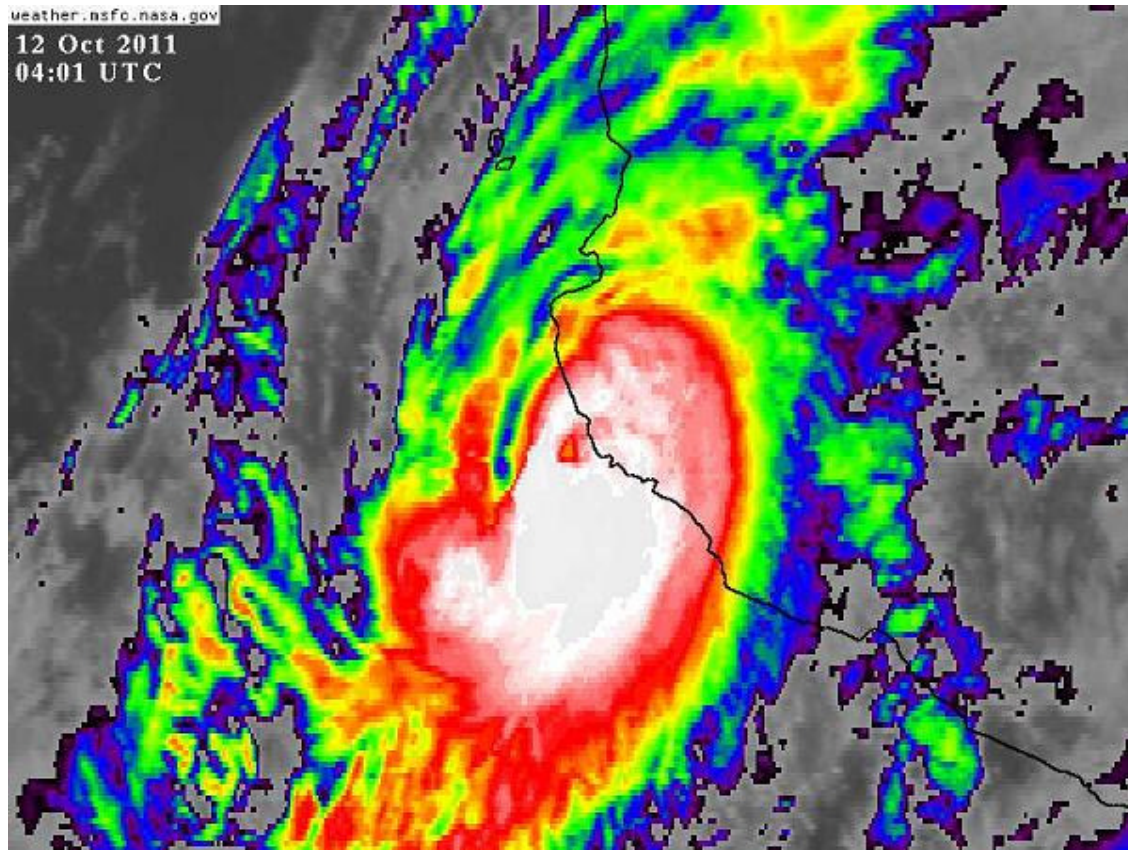
Imagery from just before landfall shows a closed, reconsolidated eyewall and eye.
